**SYRIA UPDATE II: SYRIA BURIES FOUNDATION OF SUSPECT REACTOR SITE**  
THE INSTITUTE FOR SCIENCE AND INTERNATIONAL SECURITY  
OCTOBER 26, 2007

## **SYRIA UPDATE: SUSPECTED REACTOR SITE DISMANTLED**

# **SUSPECT REACTOR CONSTRUCTION SITE IN EASTERN SYRIA: THE SITE OF THE SEPTEMBER 6 ISRAELI RAID?**

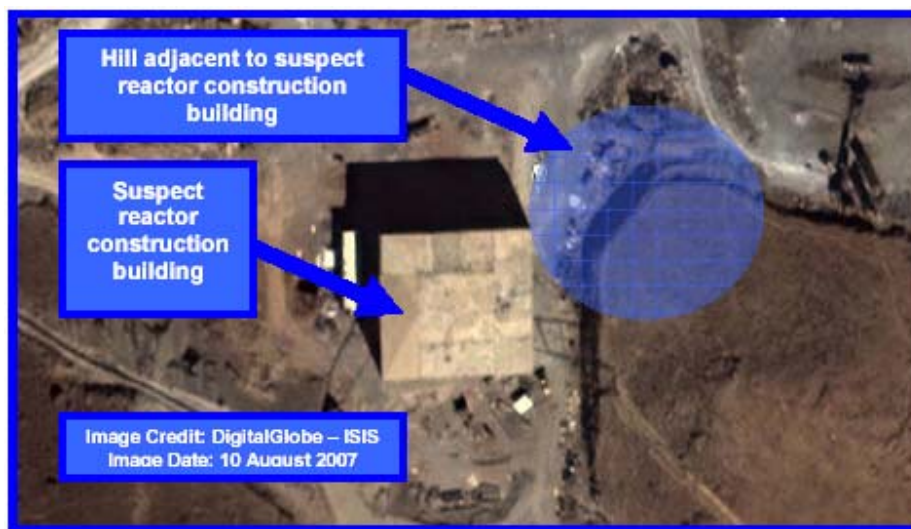
Figure 1. Suspect reactor site before September 6, 2007 Israeli raid.

A further examination of the DigitalGlobe imagery featuring the suspected Syrian reactor construction site on October 24, 2007 reveals that in addition to dismantling and removing the building, Syria appears to have buried the foundation (Figures 1 and 2). Syria bulldozed a section of a hill adjacent to the suspected reactor building and used the excavated dirt to cover over the site. Furthermore, if Syria intended to conceal an underground portion to this building that had been subsequently exposed by bombing, burying it would have been easier than removing it. The excavated hill was brought to ISIS's attention by two close readers of the imagery who noticed it.

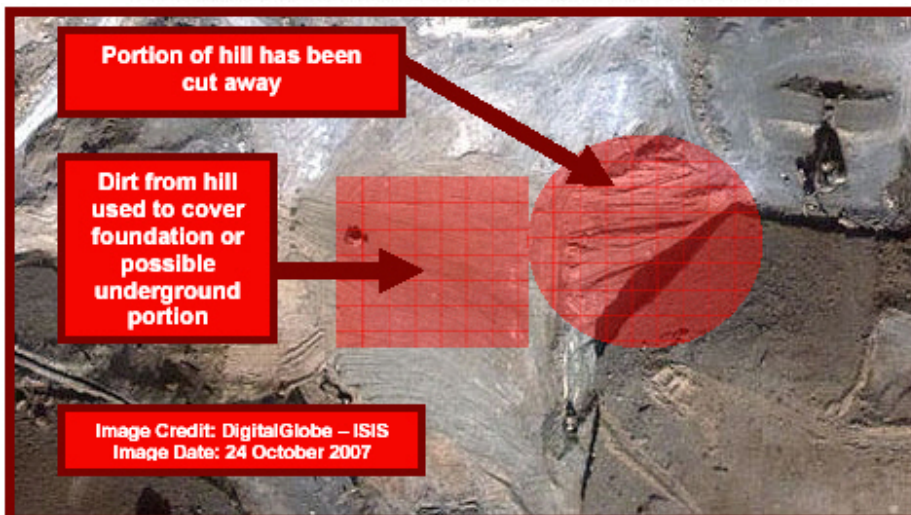
Figure 2. Suspect reactor site after September 6, 2007 Israeli raid.

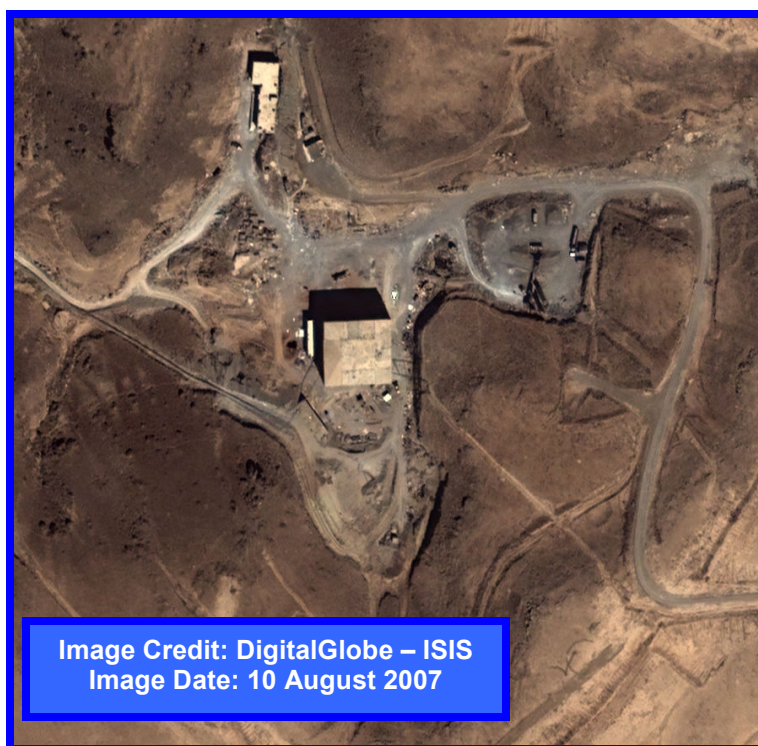
**Figure 1. Overview of suspected reactor site before September 6, 2007**

ISIS has obtained commercial satellite imagery from DigitalGlobe taken on October 24, 2007 that shows the suspected reactor construction building completely removed and the ground scraped (Figure 2). [ISIS released a report on October 23, 2007](#) that featured DigitalGlobe imagery from August 10, 2007 showing the suspected reactor construction site of the September 6, 2007 Israeli raid inside Syria. A comparison of these two images effectively confirms that this site was indeed the target of the Israeli raid (Figures 1 through 6).

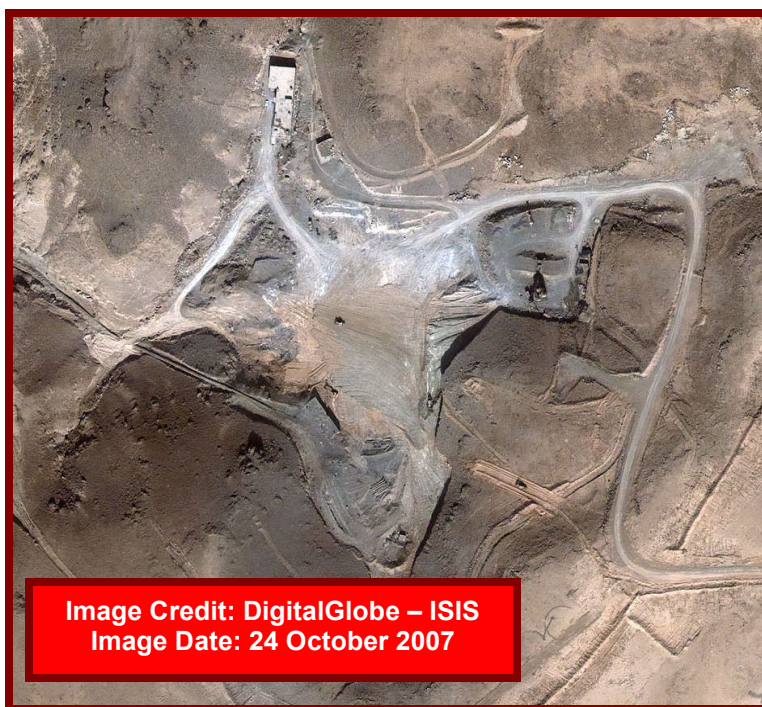
**Figure 2. Overview of suspected reactor site after September 6, 2007**

The pump house and secondary structure still remain in the October 24, 2007 imagery, but the suspected reactor building has been razed to the ground (Figures 2 and 6). Dismantling and removing the building at such a rapid pace dramatically complicates any inspection of the facilities and suggests that Syria may be trying to hide what was there. Iraq followed a similar strategy in the 1991 after the first Gulf War, though eventually the International Atomic Energy Agency (IAEA) and UN inspectors pieced together a full picture of Iraq's activities. Iran razed the site at Lavizan and insisted that no prohibited nuclear activity was conducted at the facility.

Tractors or bulldozers can be seen in the October 24 imagery where the suspected reactor building once stood. Scrape marks can be seen around the razed part of the site. There also appears to be a trench in the October 24, 2007 imagery that is better defined than in the August 10, 2007 imagery. This trench may be more visible as a result of the Syrians digging up buried pipelines running from the pump station to the now-gone suspected reactor construction building. Because of a more prominent shadow in the October 24, 2007 imagery, there appears to be evidence of an underground portion of the suspect reactor building.

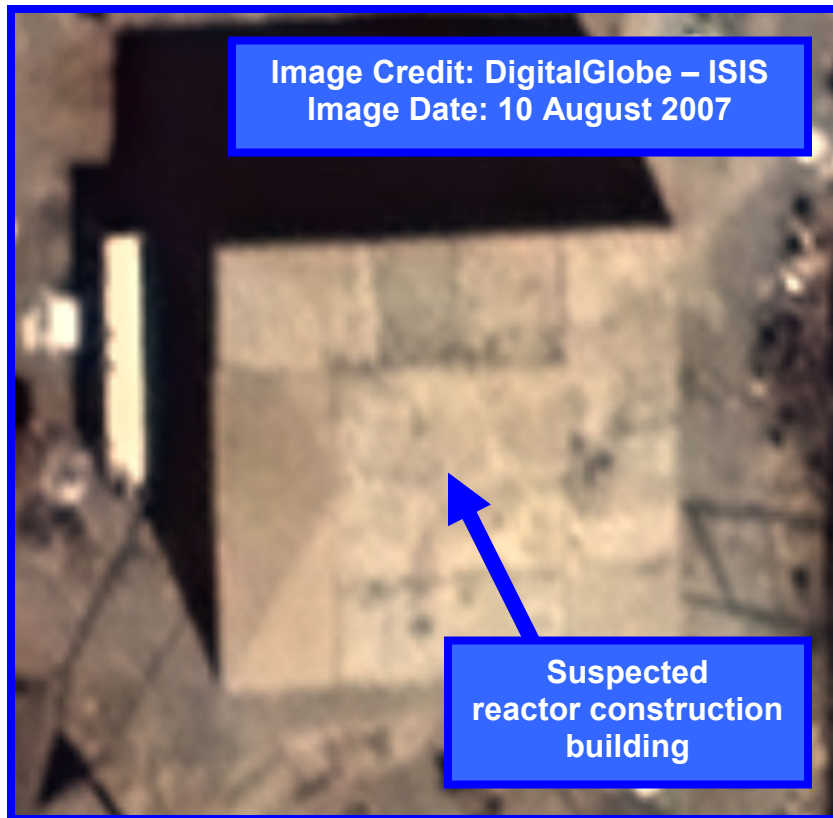
**Figure 3. Suspected reactor construction building before September 6, 2007 Israeli raid.**

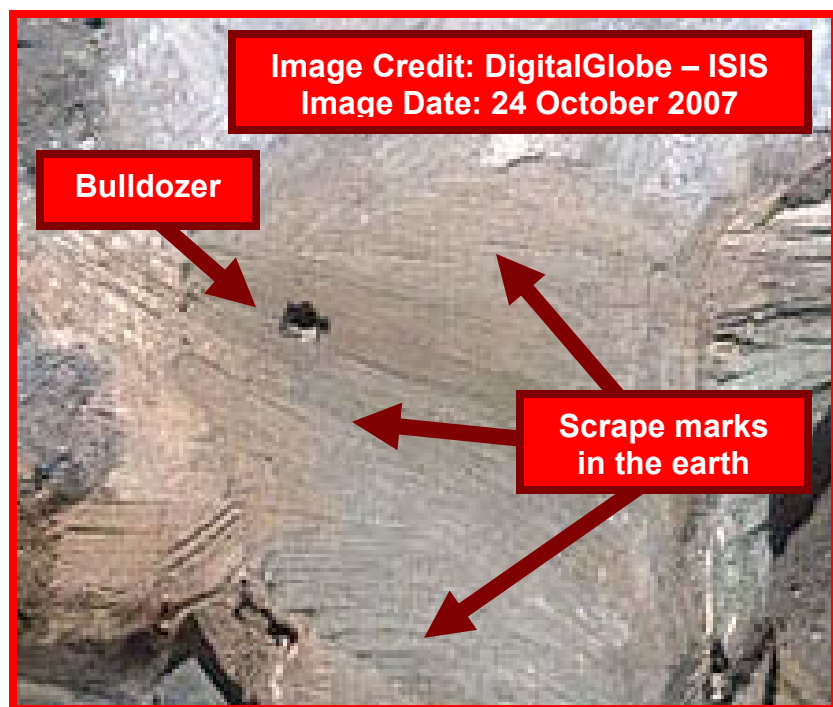
**Figure 4. Suspected reactor construction building dismantled.**

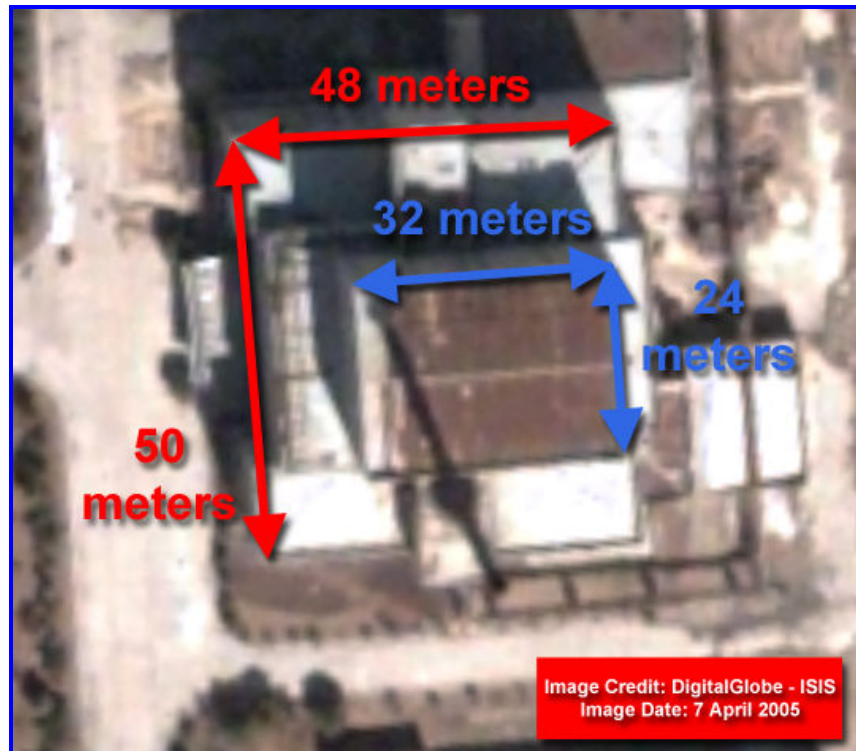
Figure 4. The five megawatt electric reactor building at Yongbyon, North Korea.

In comparing the five megawatt-electric (or 20-25 megawatt-thermal) reactor building at North Korea's Yongbyon nuclear facility to this suspected Syrian reactor building, the length of the outer walls of the structures are approximately the same (see Figures 4 and 5). The taller roof of North Korea's reactor measures approximately 32 meters by 24 meters on its sides. There also appears to be a faint square on top of the Syrian building's roof. It is unclear whether something would be built there, but its dimensions, 24 meters by 22 meters, are consistent with the subsequent construction of an upper roof. From the image, the Syrian building is similar in shape to the North Korean reactor building, but the Syrian building is not far enough along in its construction to make a definitive comparison.

If the design of the reactor is similar to a North Korean reactor, it is likely a small gas-graphite reactor of the type North Korea built at the Yongbyon nuclear site north of Pyongyang. The Syrian building size suggests that the reactor would be in the range of about 20-25 megawatts-thermal, large enough to make about one nuclear weapon's worth of plutonium each year (see Figures 4 and 5).

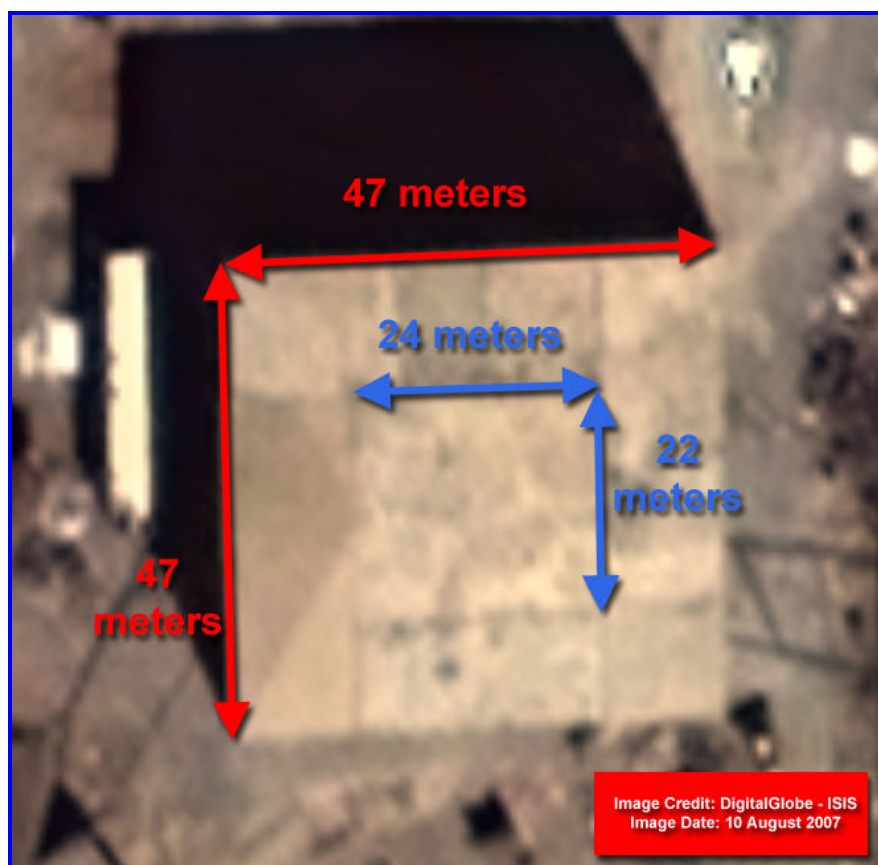
Figure 5. Possible Syrian reactor construction site.
